INVENTORY & SCHEDULE OF CONDITION RELATING TO:

**6 Ivy Hill Court
New Road
Princes Risborough
Bucks
HP27 0JL**

DATE OF RECORDING: 02/08/2010 By: Carringtons Services

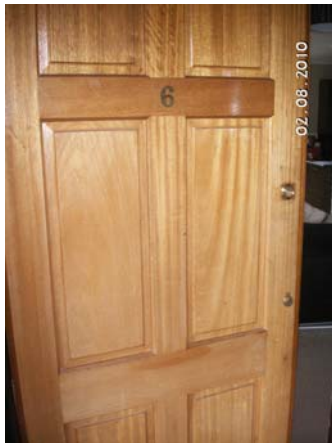
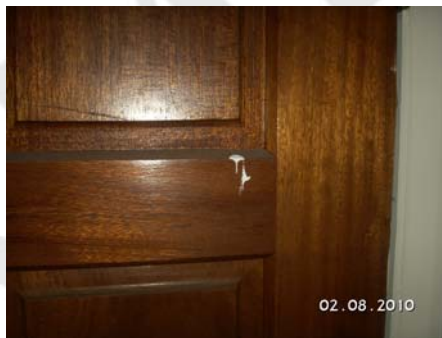
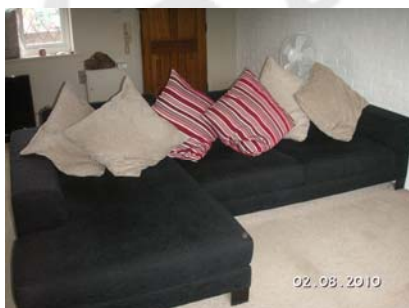
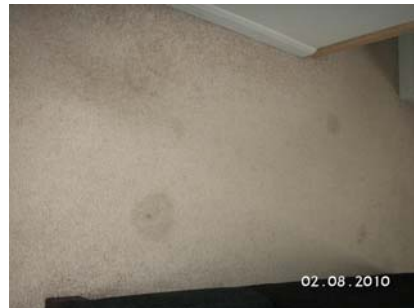
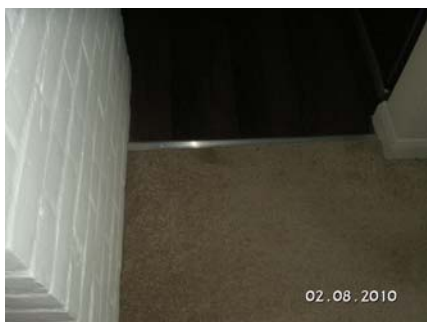
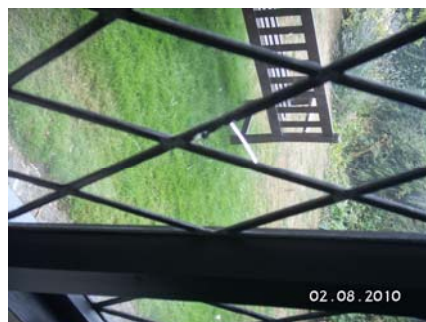
RECEPTION ROOM ONE.	DESCRIPTION	CONDITION AT CHECK IN	CHECK OUT COMMENT
FRONT DOOR	As front door in Entrance Hall.		
FLOORING	Beige medium pile carpet.	IGO. Slightly worn in walkways with five small stain between Kitchen and Hallway. Slight discolouration to carpet where rug has previously been laid. Some furniture indents.	
WALLS White painted-LHS. Cappuccino Painted-Remaining Walls.	<u>Rear-</u> Front Door. One DS. One chrome touch LS. One intercom phone. One boxed in fuse box and sockets. One house bell. One fuse socket One DS. One BT socket. One window with wooden beading. Two tacks. <u>LHS-</u> Brick wall painted white with two white ceramic half wall lights. <u>Facing-</u> One satellite and aerial point. One Sky box. One black double socket. One window with beading. One black, glass fronted electric heater.	One large crack to wall where splint is present with black cable. Cracks leading off of damaged area. Heavily discoloured. Broken. Four painted over screw holes. One screw has damage. IGO. Lights are grubby and dusty but secure. One small hole, RHS of first light. Socket is loose and needs fixing. Heater is secure but slightly dusty.

<p>One 5cm damage to plaster near cupboard units.</p> <p><u>RHS-</u> One black fuse switch. One black single LS. One Siemens' thermostat dials. One painted capped socket. Two holes and one pin above socket. One screw, painted. One door leading to Hallway and Bedrooms.</p>	<p>Damage to plaster RHS of thermostat dial.</p> <p>Various low level light usage marks. One darker scuff mark RHS of Hallway door, roughly 5cm in size.</p>	
<p>CEILING</p> <p>White Artex. White Coving.</p>	<p>Two black centre pendant lights with black ruffle fabric shades.</p>	<p>IGO and clean. IGO and clean.</p>	
<p>WOODWORK</p>	<p>Cappuccino painted wooden skirting board.</p>	<p>Consistent with use and age. Three small holes on skirting board on RHS wall. Skirting board NOT present on LHS wall. Various scuff marks to paint within skirting board on Facing wall.</p>	
<p>WINDOW</p>	<p>Black painted wooden windows with black painted handle and latch.</p> <p>Window sill is cappuccino coloured.</p> <p>One brown exterior/white interior UPVC double glazed window with white plastic handle and one window key. Window sill is cappuccino</p>	<p>Window appears dirty and discoloured low level. Latch and handle are consistent with use. One crack on centre panel window on one diamond. Various stain and chip marks present and surface dirt. One large crack to plaster near RHS window over looking garden. Window appears clean and IGO, slightly dusty. One black scuff mark along mid level. Light usage marks.</p>

<p>coloured.</p> <p>Fittings-</p> <p>One black and brushed grey flannel-ette five seater corner sofa with four off cream and two red and stripped cream cushions.</p> <p>One small cupboard under stairs on LHS wall-</p> <p>One built in wall safe.</p> <p>One SS.</p> <p>One single LS.</p> <p>Various electrical equipment i.e. VCR and floor tiling.</p> <p>One built in wooden cabinet with four glass panel mirror acting as door.</p> <p>Cabinet has various hooks throughout.</p> <p>Two hanging rails.</p>	<p>One small hole in filler RHS bottom corner.</p> <p>Sofa, IGO and clean.</p> <p>Fire safety approved.</p> <p>Cupboard has various wrought plugs, filler marks and scuff marks consistent with use as cupboard.</p> <p>One hook missing on second level up.</p>	
--	---	--	--

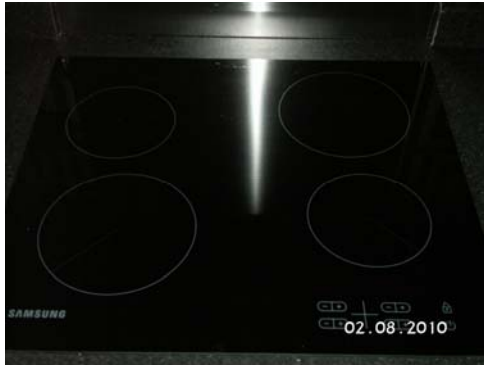
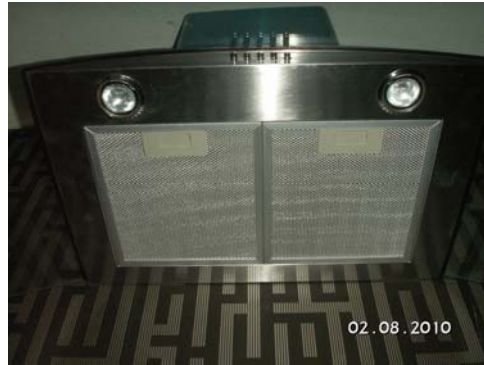
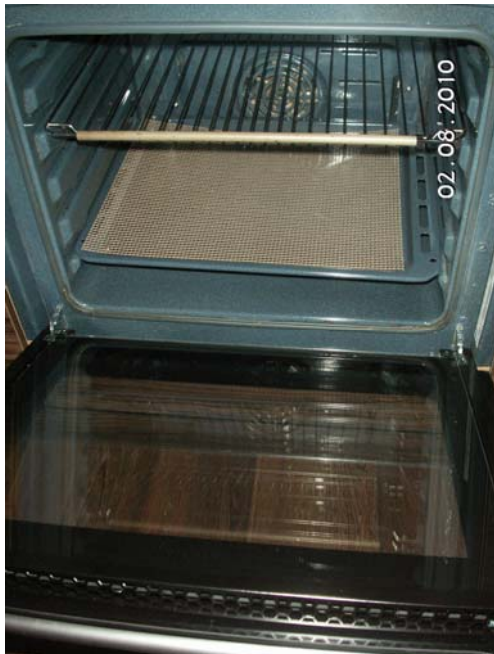
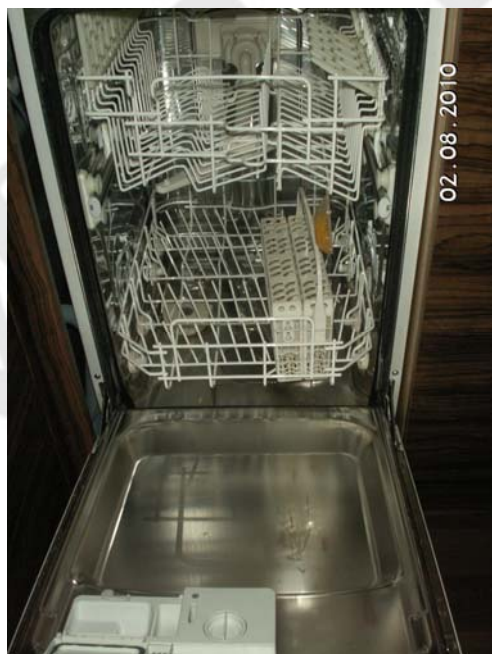
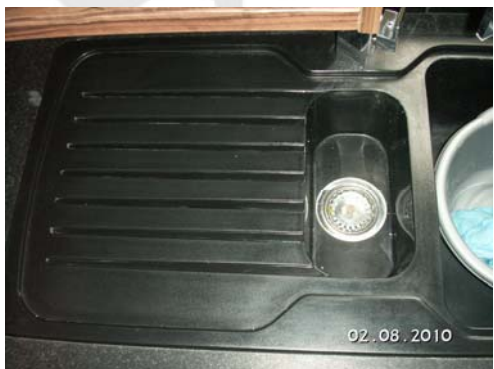
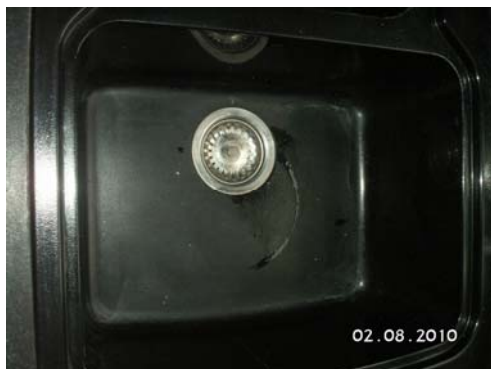
KICTHEN.	DESCRIPTION	CONDITION AT CHECK IN	CHECK OUT COMMENT
DOOR	No door present. Archway leading through to Kitchen.		
FLOORING	Dark wooden click laminate flooring.	IGO throughout. Clean with one 5cm chip mark to LHS corner below sink.	
<p>WALLS</p> <p>Cappuccino Painted. Black shiny beveled effect tiled splash back and black and white zigzag effect papered wall.</p> <p>Kitchen Units- Dark brown wooden effect units with beech effect casing and chrome handles. Dark brown wooden effect kickboard and finals.</p>	<p><u>Rear-</u> Archway leading to Reception Room One. Work bench island housing Washing Machine to Reception side.</p> <p>One black with light mottles effect worktop. Kitchen side has one single, low level cupboard with five small wine shelves to LHS of cupboard.</p> <p><u>LHS-</u> Two head height cupboards. One slim Matsui Dishwasher- Serial No: 831007505 Model No: MF145. One under cupboard sink with sliding grey waste bins X2. One black and mottles effect worktop. One black resin one and a half sink and drainer with chrome mixer tap. Two plugs, those are in-built. One UPVC double glazed window. Black splash back tiles.</p>	<p>Washing machine appears clean, but soap draw box is broken and difficult to pull out. Kickboard is damaged below washing machine and at an angle. Remainder panel to RHS of washing machine is loose low level. Brick work appears unpainted. IGO, some surface dirty present.</p> <p>IGO Clean and IGO.</p> <p>Slightly tarnished near sink on LHS. Tap is loose. Drainer is consistent with use with lime scale build up.</p> <p>Clean and IGO.</p>

<p><u>Facing-</u> One large head height cupboard. One slightly smaller head height cupboard. One extractor fan- chrome and glass with blue chrome panel. Wall has wallpaper as stated. Two black DS. One black cooker isolator switch and single socket. Black mottles worktop. One SSt splash back area near hob. One Samsung black glass foring hob, with electric touch. One SSt and black Samsung oven. One low level cupboard low level to LHS of oven with built in white wire racks. Four low level draws LHS of oven.</p> <p><u>RHS-</u> One American style Samsung silver fridge/freezer with ice making machine.</p> <p>Wall appears to be Magnolia painted but then plane plaster behind fridge to LHS of fridge. Worktop off cut present at back of fridge.</p>	<p>Crumbs present and is dirty. Hood is clean and IGO.</p> <p>Light scratch marks either side of hob.</p> <p>IGO and clean.</p> <p>Professionally clean to a high standard.</p> <p>Clean and IGO, handles are slightly dirty.</p> <p>Various light scuff marks, low and mid level. One 1cm dent to freezer door low level. Surface dirt present. Both fridge and freezer appear domestically cleaned and IGO.</p>

CEILING	One black and chrome four tier strip light.	IGO. Slightly dusty.	
White Artex. White Coving.		Ceiling has damage where previous light was. Cobwebs present.	
WOODWORK	N/A		
WINDOW	One small single opener, externally brown, internally

<p>white UPVC double glazed window and key. Black tiles windowsill and part edges with unevenly painted Cappuccino paint to top area of window.</p>	<p>One filler mark present to RHS of window. Some cracks to plaster on LHS of window.</p>	
--	---	---	--

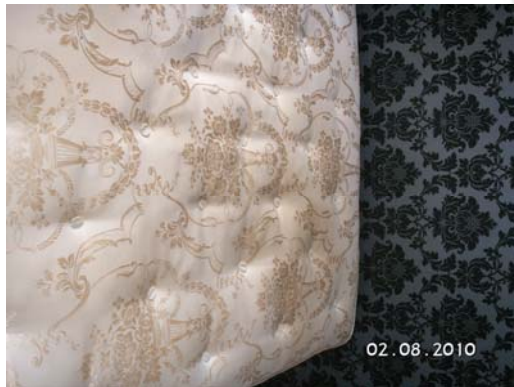
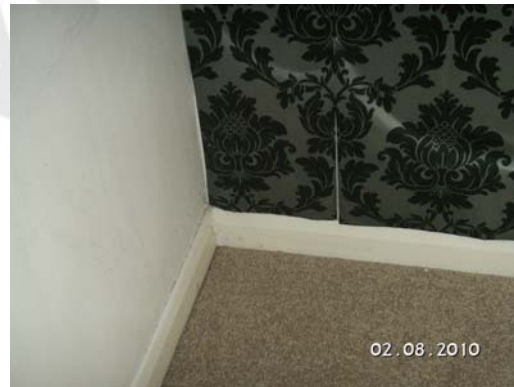
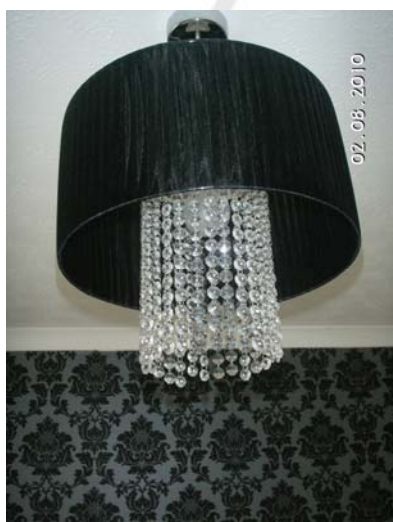
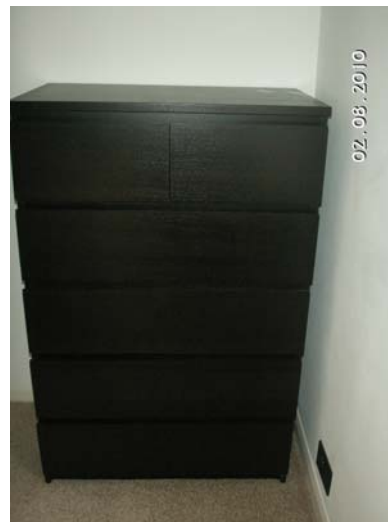
BEDROOM ONE.	DESCRIPTION	CONDITION AT CHECK IN	CHECK OUT COMMENT
DOOR	<p>One natural wooden, four paneled door.</p> <p>One obscured glass panel above door.</p> <p>Door frame is white gloss wooden painted.</p>	<p>IGO throughout with pencil marks present at top of door externally and near lock.</p> <p>IGO, some light chips present low level.</p>	
FLOORING	Beige medium pile carpet.	IGO and clean.	
WALLS White painted to three sides and black and silver wallpaper matching Hall.	<p><u>Rear-</u> Wall painted white.</p> <p>Door to Hallway. One black DS. One Siemens white thermostat dial. One brushed chrome touch LS.</p> <p><u>LHS-</u> Wall painted white.</p> <p>One dark wooden six draw unit. Two draws are smaller at top.</p> <p><u>Facing-</u> One black DS. One black fuse switch. One black glass fronted electric radiator. One window with wooden bead.</p> <p><u>RHS-</u> Black and silver pattern wallpaper. One white external wall vent. Two black free standing shelves.</p>	<p>Scuff marks present mid level.</p> <p>Large filler marks which have been sanded down but not re-painted, head height at centre of wall. IGO and clean.</p> <p>IGO.</p> <p>Scuff marks low level to RHS of window.</p> <p>Wallpaper coming loose at base of wall throughout. Clean, but slightly loose.</p>

CEILING White Artex. White Coving.	One chrome and white centre pendant light with glass beading and black fabric shade.	Some damage to paint above draw unit. IGO and clean.

WOODWORK	White gloss painted skirting boards.	Slightly discoloured behind bed and in corners near bed. White paint present below and RHS of radiator. Consistent with age but in fairly good order.	
WINDOW	One brown externally, white internally UPVC double glazed window. One black, black out roller blind. One wooden bead above window with four plastic screws attached to beading. One white painted wooden sill. One window key present. One black home easy control pad to access lights. One double duvan and matching mattress.	Clean and IGO. Clean and IGO. Extensively marked and uneven paint throughout. Stained, and fire safety label present.

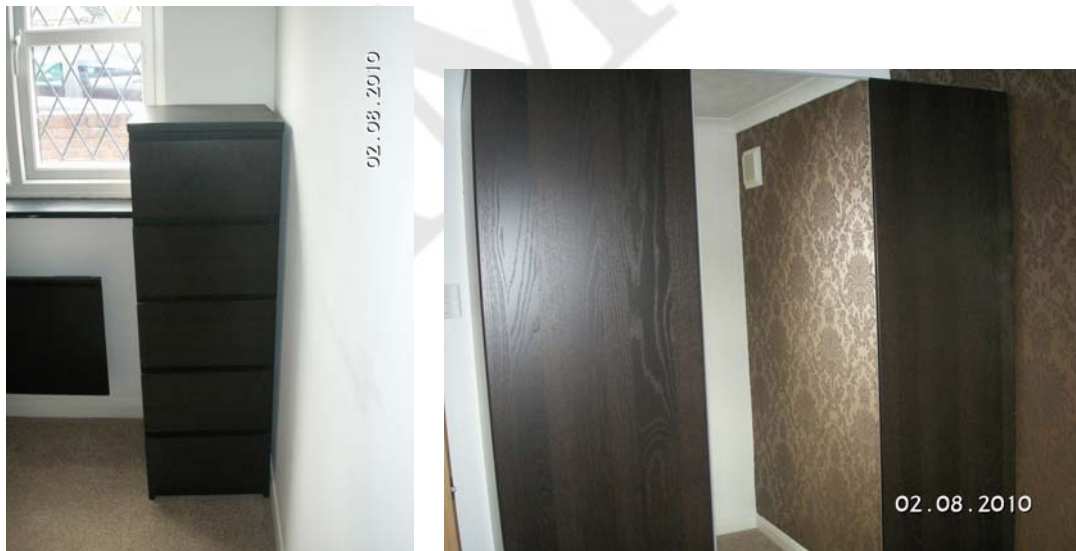
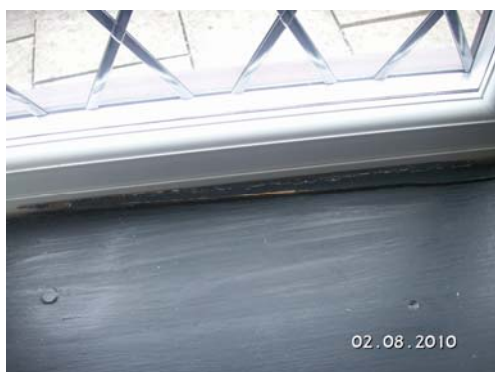
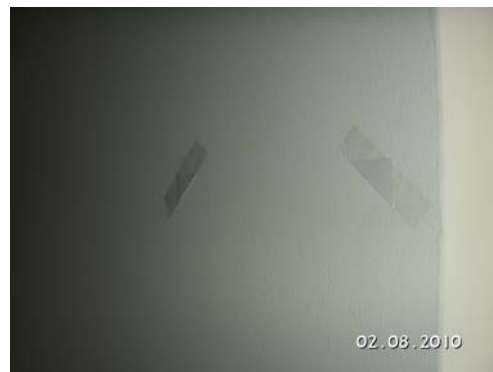
BEDROOM TWO.	DESCRIPTION	CONDITION AT CHECK IN	CHECK OUT COMMENT
DOOR	<p>One natural wooden, four paneled door. One brushed chrome door hook. One obscured glass panel above door. Door frame is white gloss wooden painted.</p>	<p>IGO. Paint present on panel. Various light scuff marks present. Black marks at top due to door hook.</p>	
FLOORING	Beige medium pile carpet.	IGO.	
<p>WALLS</p> <p>White painted with brown and gold effect papered wall.</p>	<p><u>Rear-</u> Wall painted white. Door leading to Hallway. One single black LS.</p> <p>One set of small black five draw chest of draws.</p> <p><u>LHS-</u> White painted. One DS. One capped socket. One Siemens thermostat dials. One dark wooden three door wardrobe with full length glass door in centre- One hanging rail. One slide out hook rail. One slide out draw at base. One single section hanging rail.</p> <p><u>Facing-</u> Patterned effect wallpaper. One white external wall vent.</p> <p><u>RHS-</u> White painted. One window with wooden beading. One black DS. One black fuse switch. One black glass fronted electric radiator.</p>	<p>IGO. One screw missing from LS.</p> <p>Paint present. Painted over.</p> <p>Slightly dirty low level.</p> <p>One small chip low level at centre of wall.</p> <p>IGO, but dusty. Two areas of tape present to LHS of</p>

<p>window. Paint chipping near extractor fan. Scratch mark above casing of window.</p>	
<p>CEILING</p> <p>White Artex. White Coving.</p>	<p>One centre pendant light with bulb.</p>	<p>Cobwebs present throughout. Protector is loose but is present.</p>	
<p>WOODWORK</p>	<p>White gloss skirting boards.</p>	<p>Dusty throughout with light usage marks.</p>	
<p>WINDOW</p>	<p>One brown externally, white internally UPVC double glazed window. White handle and one window key. One black painted wooden window sill.</p>	<p>IGO and clean.</p> <p>White paint marks throughout, but consistent with use. One large split to the wood closest to the window.</p>

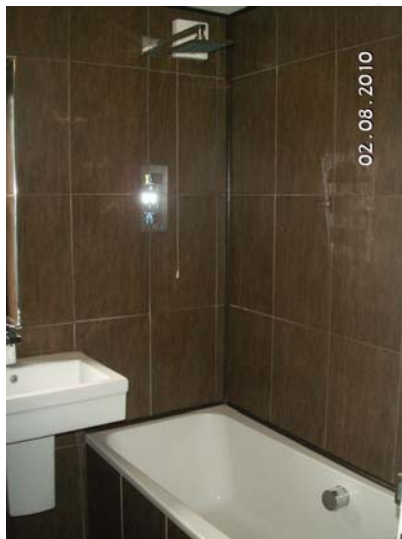
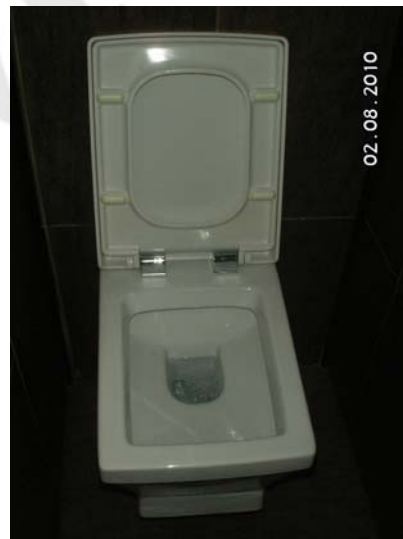
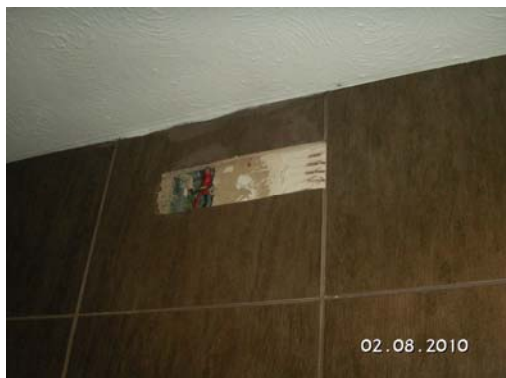
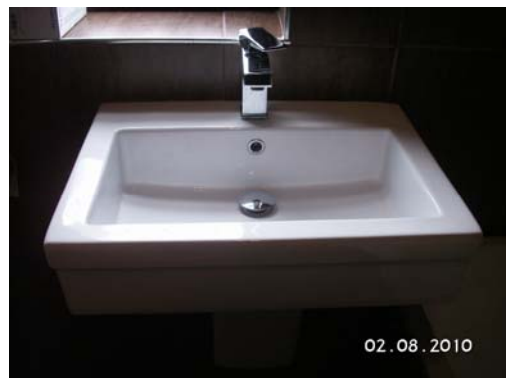
BATHROOM.	DESCRIPTION	CONDITION AT CHECK IN	CHECK OUT COMMENT
DOOR	<p>One natural wooden, four paneled door.</p> <p>One brushed chrome door hook.</p> <p>One obscured glass panel above door.</p> <p>Door frame is white gloss wooden painted.</p>	<p>IGO.</p> <p>IGO, some light usage marks low level.</p>	
FLOORING	<p>Brown brushed effect tiles.</p>	<p>Some water marks present under sink.</p> <p>IGO.</p>	
<p>WALLS</p> <p>Brown brushed effect tiles.</p>	<p><u>Rear-</u> Door leading to Hall. Brown tiled area.</p> <p><u>LHS-</u> Wall is fully tiles floor to ceiling.</p> <p>One chrome towel holder. One large chrome push flush built into wall.</p> <p>One square free standing WC with plastic seat and lid and chrome attachments.</p> <p><u>Facing-</u> Fully tiles floor to ceiling. One chrome shaver socket. One chrome soap dispenser unit. One chrome toilet roll holder. One window. One free standing square white ceramic sink with chrome mixer tap and built in chrome plug unit. One Vent-Axia white wall vent. One chrome square shower/rain head attachment. Three built in chrome taps for shower attachment.</p>	<p>One large hole purposely cut in top of tile above head with wires taped and assumed cut off. Clean and IGO.</p> <p>One crack to tile LHS of sink.</p> <p>Clean and IGO.</p>

<p><u>RHS-</u> Fully tiles wall leading to white resin full length bath with chrome twist plug and twist. Bath panel is brown brushed tiles same as flooring and walls.</p>	Bath and bath panel are clean and IGO.	
<p>CEILING White Artex.</p>	<p>One brown, what looks like disused light. One chrome three tiered spot lights.</p>	<p>Damage to ceiling where previous light has been. One 5cm damage to ceiling above bath.</p>	
WOODWORK	N/A		
WINDOW	<p>One dark brown externally/internally obscured UPVC double glazed window. Chrome handle and one window key. One black painted wooden window sill.</p>	<p>IGO and clean. Some chips to tiles around window edging.</p>
